BALTIC MILLS DAM
NH 00273

PHASE I INSPECTION REPORT
NATIONAL DAM INSPECTION PROGRAM

FEBRUARY 1979

Identification No.: NH00273
Name of Dam: Baltic Mills Dam
Town: Enfield
County and State: Grafton County, New Hampshire
River: Mascoma River
Date of Inspection: November 8, 1978

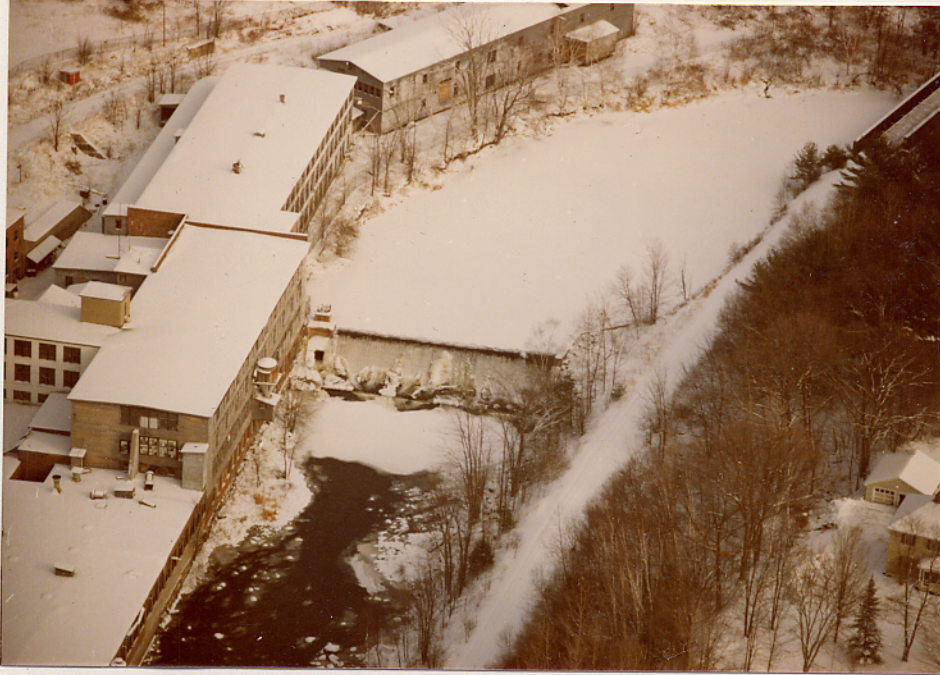
Figure 1 - Overview of Baltic Mills Dam.

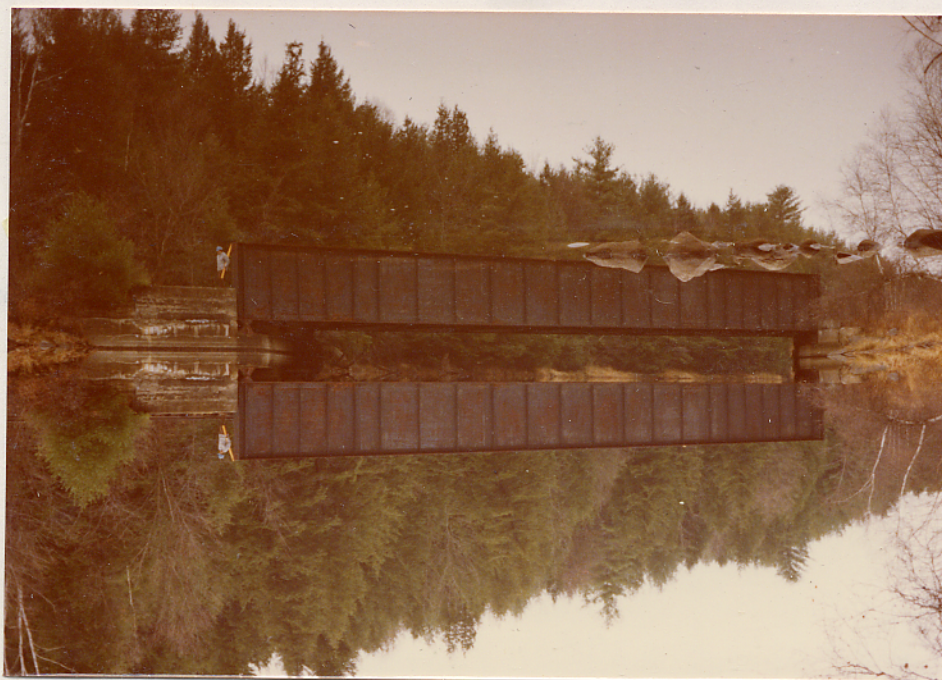
A railroad bridge crosses the reservoir east of the dam, about 300 feet upstream. (See Appendix C - Figure 7.)

Figure 7 - Looking east at B & M Railroad Bridge located about 300 feet upstream of dam.

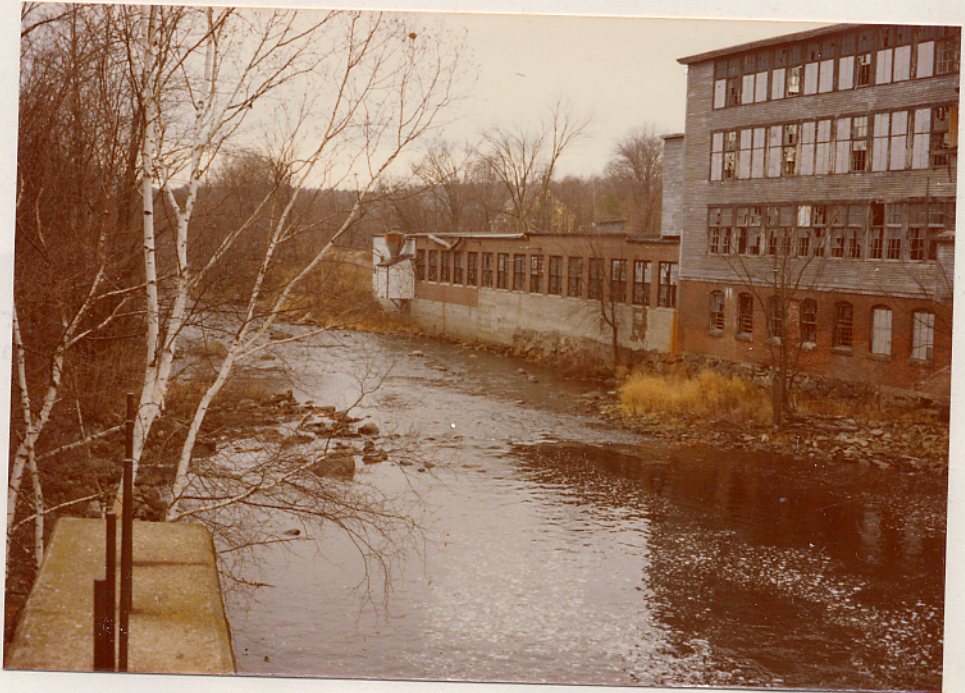
e. Downstream Channel. The channel immediately downstream of the dam is wide and unobstructed. (See Appendix C - Figure 8.) Boulders are exposed in the channel bottom, but it was not possible to determine visually whether the downstream channel invert was primarily bedrock or soil.

Figure 8 - Looking west at downstream channel from south abutment.
